# **AL-BUKHARIA FIRE**

## ***Urgent Rehabilitation Works***

**Abstract:** The paper presents an overview of the urgent strengthening and repair works carried out for *Al-Bukharia* downtown market, the oldest and the most famous market in Amman / Jordan, after a severe fire in August, 2009. In-situ evaluation/inspection revealed several architectural damages and vast commercial losses, on one hand, and a substantial loss of strength of many super-structural elements, on the other. Some internal ground floor columns and a skylight adjoining slab were found in rather bad structural condition, similarly, stone facades overlooking the internal skylight exhibited excessive spalling and sloughing off. These defects were considered very serious as they could endanger the safety of the whole structure. Consequently, immediate structural upgrading interventions and architectural rectification/decorative actions were decided to enhance the overall condition of the market with the intention to bring it back to service in less than one-month time. The paper will focus on showing different types of damages caused by the fire, their extent and assessment, and finally, the appropriate options, s

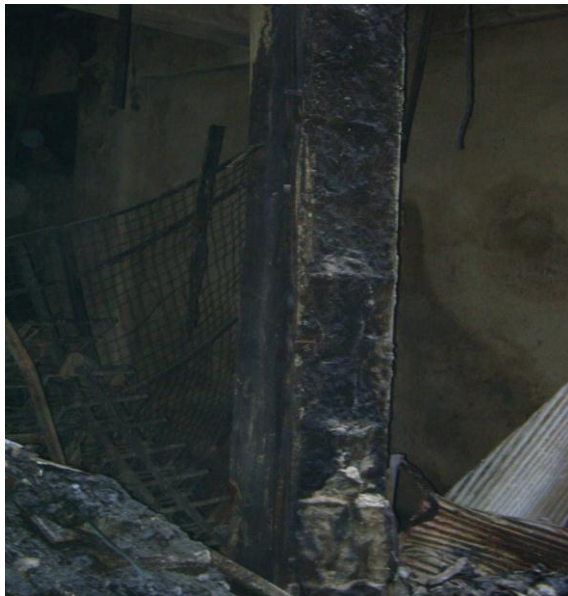
*Fig.(3)*

1. Some stone cladded columns, particularly those located within the interior approaches, at edges of stores fronts, exhibited severe distress, burns, and explosive spalling, associated with low quality packing concrete [Fig.(3)]. Indicating significant strength reduction.

The apparently defected ground floor columns at AL-Balabseh Market were jacketed with rich reinforced concrete sections. An epoxy resin was employed for fixing the shear anchors (dowels), as shown in Fig.(9).

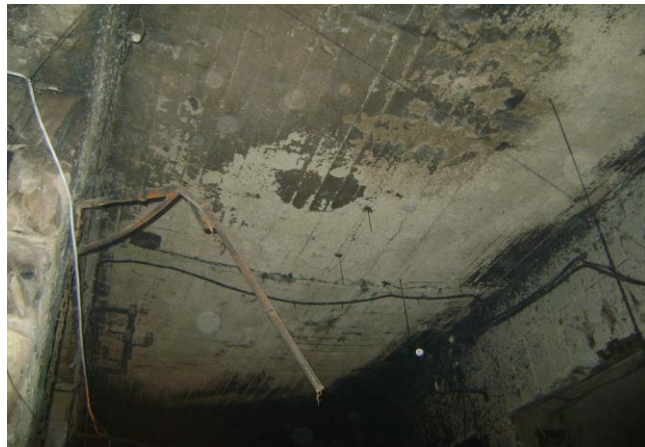
*Fig.(4)*

2. Excessive sagging (resulting from thermal expansion) of the slab of the corridor adjacent to the skylight (at its ground floor slab level) [Fig.(4)], accompanied with poor quality concrete and under-reinforcement with light rebars. Excessive crack formation was also observed within the slab soffit. Actually the slab “here in after, referred to as the *Skylight Slab*” remained stable but was felt close to collapse, therefore temporary support (jacking) was immediately provided.

The excessively deflected and deteriorated “Skylight Slab” at AL-Balabseh Market was provided by an independent/bypass composite system [Fig.(10)] comprising an underneath R.C slab on corrugated steel sheets carried by steel I-beams and H-columns supported on R.C pedestals.

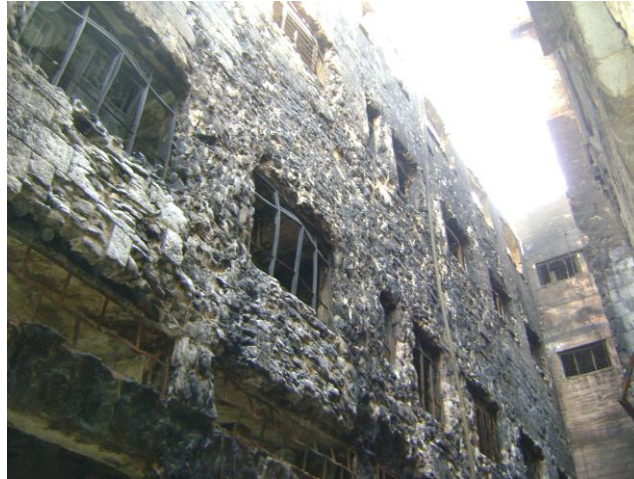
*Fig.(5)*

1. Severe burns and significant sloughing off and spalling of large portions of the skylight internal stone facades, Fig.(5).
2. Moreover, the upper faces of the skylight brick wall facades were burned.

The extremely affected AL-Balabseh skylight masonry/stone facades were decided to be repaired with multi-layer reinforced (with wire mesh) plastering, as shown in Fig.(11). This technique was chosen in lieu of reinstatement with similar stone cladding since the (re-cladding) slow process will delay the progress of the whole work; an option that we didn't have in our urgent case. Yet, plastering didn't impair or obscure the overall original architectural pattern of the building as it is applied only for internal facades

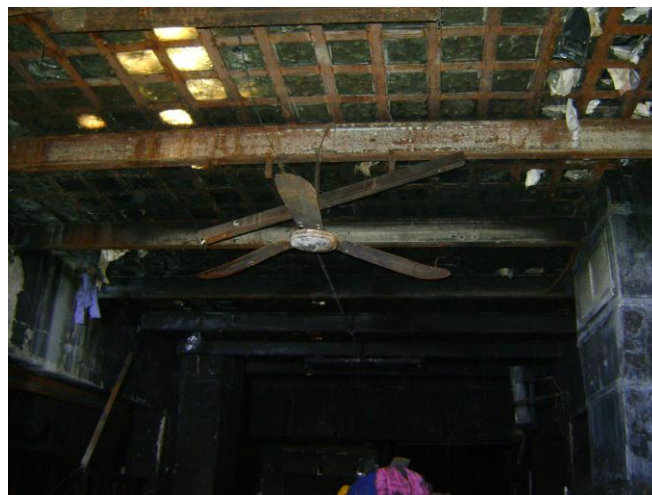
*Fig. (6)*

1. Broken cellular glazing , [Fig.(6)], associated with distortion of surrounding steel plate mesh.
2. Buckling and/or twisting of supporting steel I-Beams.

The damaged glazed/steel slabs at Philadelphia Market were completely replaced with a more efficient R.C solid slabs carried by corrugated steel sheets. The existing supporting steel I-beams (transoms) were further enhanced by additional (alternate) new I-beams, [Fig.(12)].

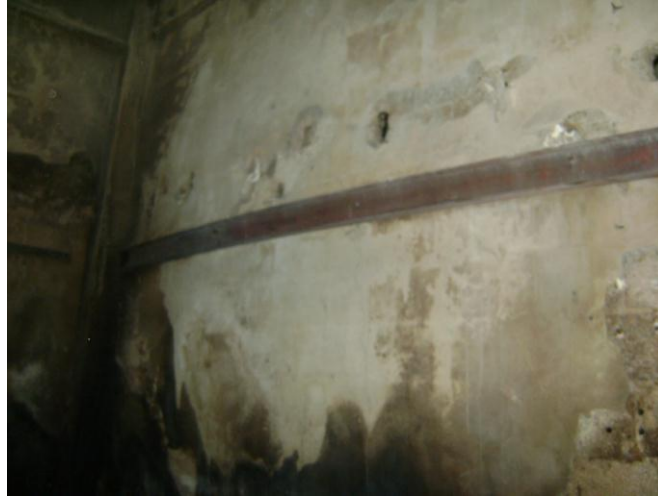
*Fig.(7)*

1. Out of plane thermal bulging or bowing of masonry block partitions, [Fig(7)].

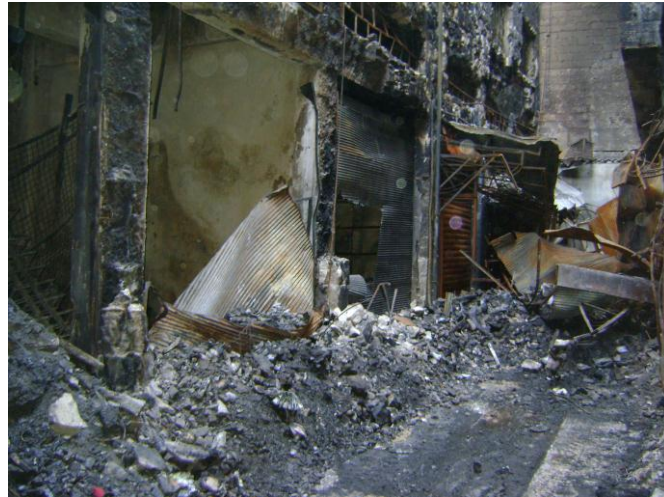
*Fig.(8)*

7. Large amount of fire debris; like charring wood, soften glass and plastic, molten PVC pipes, aluminum frames, damaged/destroyed false ceilings, partitions, panels, doors, windows,.. etc. was accumulated within the two markets, [Fig.(8)].
