# **AL-BUKHARIA FIRE**

## ***Urgent Rehabilitation Works***

**Abstract:** The paper presents an overview of the urgent strengthening and repair works carried out for *Al-Bukharia* downtown market, the oldest and the most famous market in Amman / Jordan, after a severe fire in August, 2009. In-situ evaluation/inspection revealed several architectural damages and vast commercial losses, on one hand, and a substantial loss of strength of many super-structural elements, on the other. Some internal ground floor columns and a skylight adjoining slab were found in rather bad structural condition, similarly, stone facades overlooking the internal skylight exhibited excessive spalling and sloughing off. These defects were considered very serious as they could endanger the safety of the whole structure. Consequently, immediate structural upgrading interventions and architectural rectification/decorative actions were decided to enhance the overall condition of the market with the intention to bring it back to service in less than one-month time. The paper will focus on showing different types of damages caused by the fire, their extent and assessment, and finally, the appropriate options, s

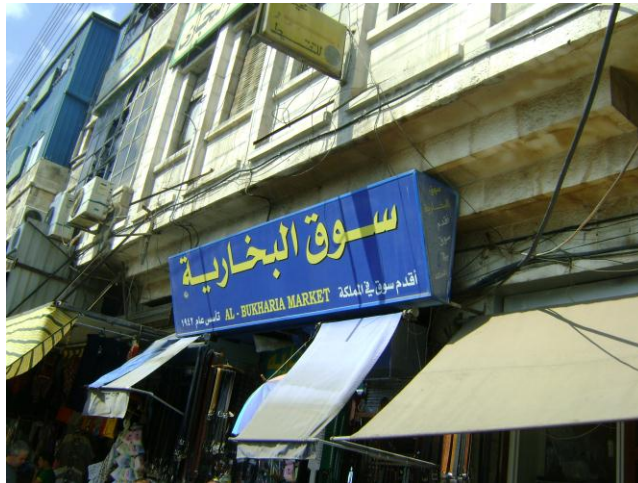
*Fig. ( 1 )*

Also amazingly, the fire did not spread into the adjacent “AL-Bukharia Market” despite it was unconsciously, but reasonably, given its name, since AL-Bukharia Market is the oldest (established in 1942) and the most famous market in Amman-Downtown Fig.(1). Therefore, the sad incident gained both; public sympathy and authority attention.

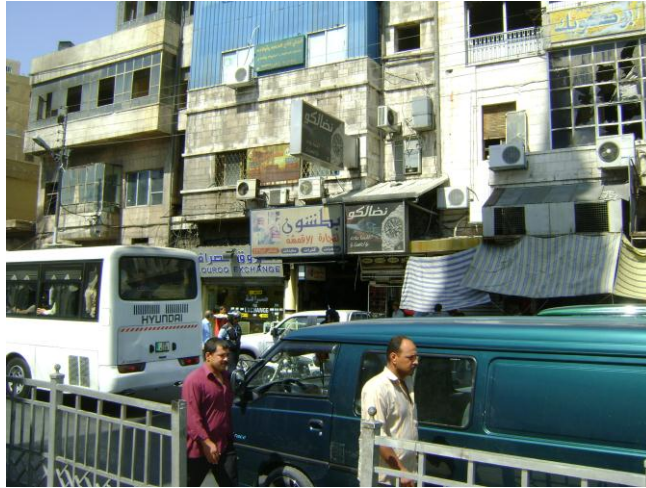
*Fig.(2)*

**2.3 Description:** Two adjacent buildings containing three markets [Fig(2)]:

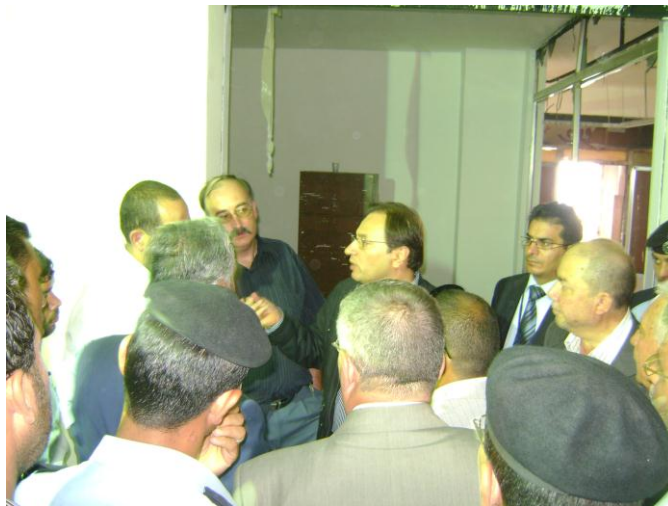
*Fig.(14)*

The whole rehabilitation and repair works were completed within the targeted time (30 days) coincidence with the Holly Ramadan Month, where the activities continued all days and nights until the reopening ceremony on **16/9/2009** ;
